PUBLIC ROADS

VOL. 24, NO. 4

APRIL-MAY-JUNE 1945

Page
Structural Efficiency of Transverse Weakened-Plane Joints	83
Disintegration of Bridge Concrete in the West	98
The Federal-Aid Highway Act of 1944	112

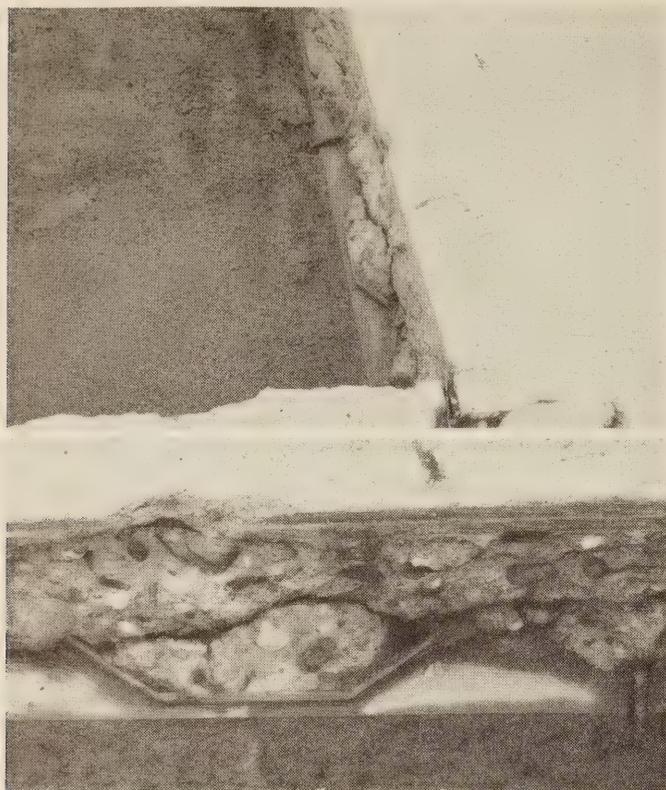
FIGURE 13.—EXPOSED EDGE OF TYPE C WEAKENED-PLANE JOINT.

The difference in the behavior of the special joint as compared with that of the other joints is an indication that the bottom parting strip failed to fracture the pavement as planned. Figure 13 shows the exposed joint edge of the special joint after a section of the pavement adjacent to the joint had been removed. This illustration shows rather conclusively that the bottom parting strip did not function in the intended manner.

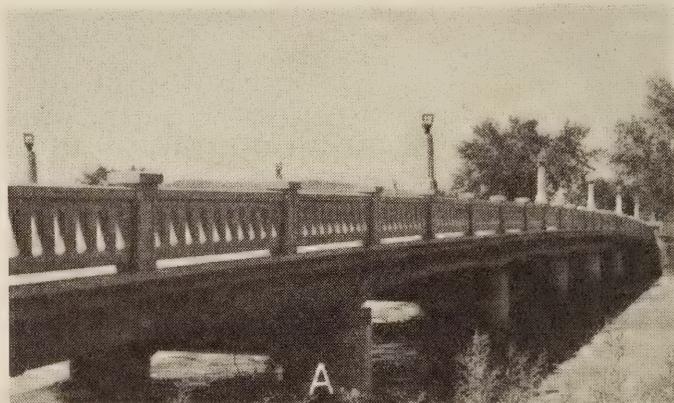
FIGURE 1.—(A) OLD CONCRETE BRIDGE IN WYOMING IN GOOD CONDITION AFTER 22 YEARS. THE BRIDGE WAS BUILT IN 1921. (B) AN EXAMPLE OF TYPE 1 DETERIORATION IS A BRIDGE IN WYOMING BUILT IN 1921. THE CONCRETE IS IN GOOD CONDITION EXCEPT FOR CRACKS DUE TO IMPACT FROM COLLIDING VEHICLES.

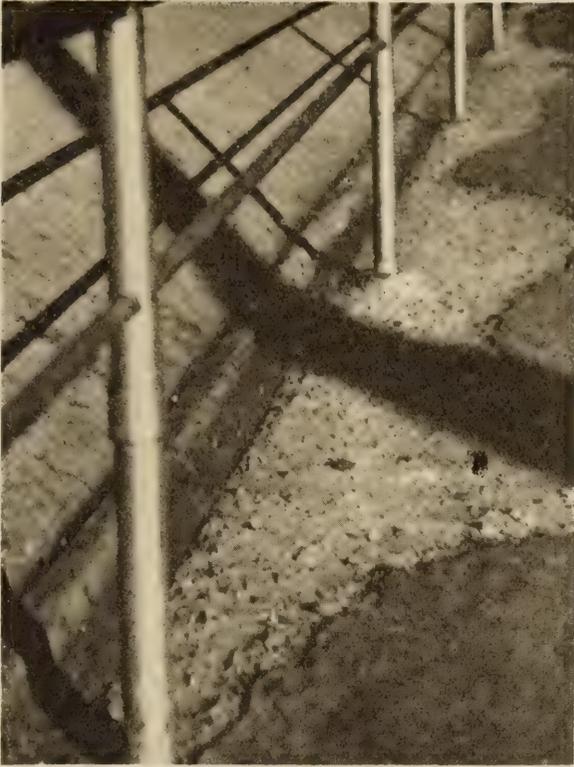
FIGURE 4.—AN EXAMPLE OF TYPE 3 DETERIORATION ON A BRIDGE IN WYOMING, SHOWING SURFACE SCALING DUE TO THE USE OF SALT FOR ICE REMOVAL.

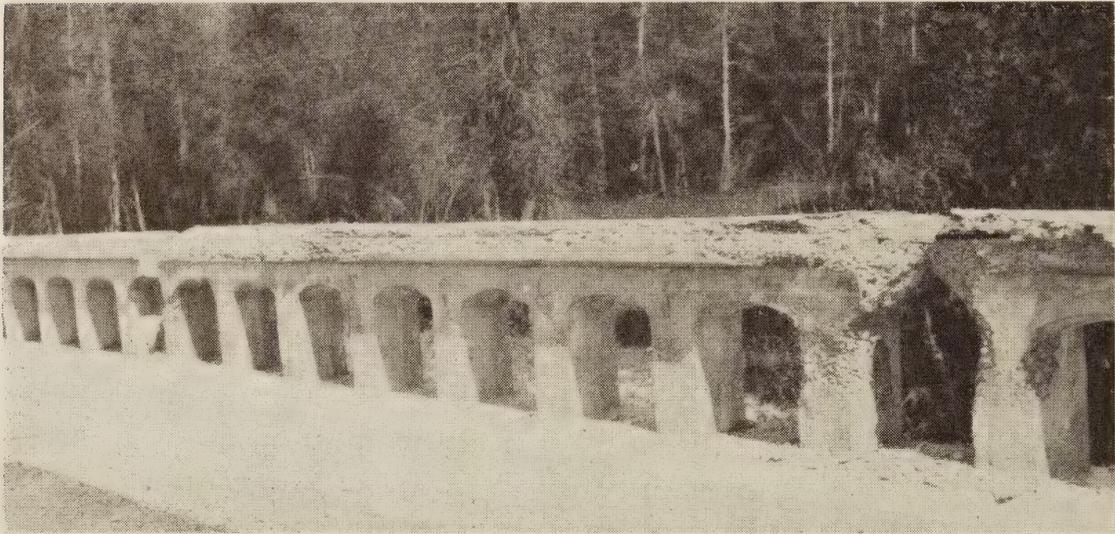
FIGURE 7.—FAILURE OF A HANDRAIL IN WYOMING DUE TO ACCELERATED WEATHERING, AN EXAMPLE OF TYPE 2 DETERIORATION.
